## FUNCTIONAL EVALUATION OF RURAL HOUSING BASED ON A SEISMICALLY OPTIMIZED PROPOSAL WITH RESPECT TO THE E-080 STANDARD, SHAULLO CHICO BAÑOS DEL INCA

Alexa Becerra

Universidad Privada del Norte - Cajamarca

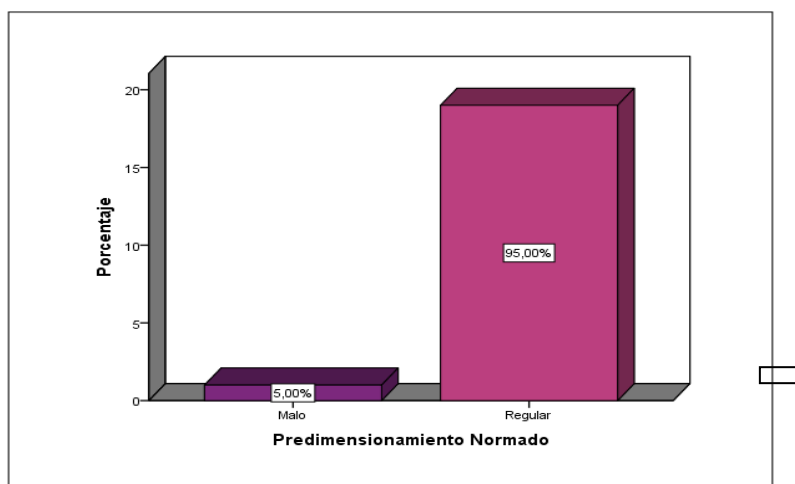
**Figure 1: Resizing According to the Regulation**

Table 1 and Figure 1 provide a detailed overview of the evaluation of adobe housing in the Shaullo Chico Primary School. The results reveal that 5% of these homes obtained a rating of "bad" in terms of geometric pre-dimensioning, which indicates significant deficiencies in their structure. In contrast, 95% of the homes were classified as "fair," pointing out that most of them have deviations from the criteria of the E-080 regulation in this regard. Notably, no housing was classified as "good," suggesting that although some of them may maintain an acceptable functional state, they still have structural defects and do not fully meet regulatory standards. These results underscore the need to address deficiencies in geometric pre-dimensioning to improve the seismic resistance of homes in this area, where factors such as adobe durability and other construction aspects can also influence their functionality.

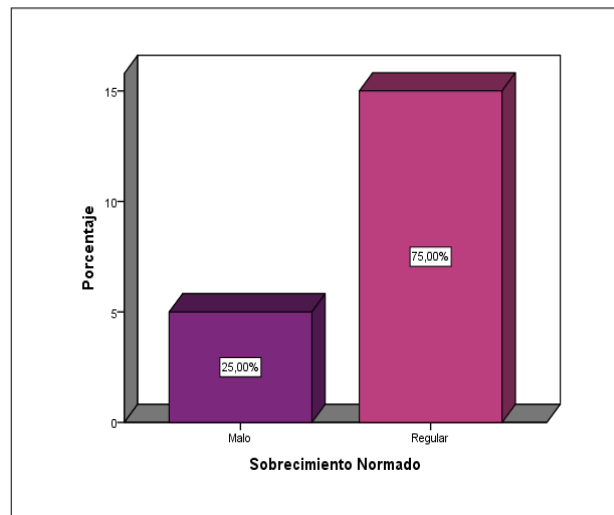
**Figure 2:** *Overcrowding According to the Regulations*

Table 2 and Figure 2 present the results of the evaluation of the over-foundation in adobe houses in the Shaullo Chico Primary School. The data reveals that 25% of the homes were rated as "poor" due to the absence of overhang, raising significant concerns in terms of safety and structural stability. On the other hand, 75% of the homes received a rating of "fair," which indicates that the vast majority have deviations from the dimensions of overhang required by the E-080 standard. Notably, no homes were found that fully met the "good" criteria. This situation represents a risk not only for the inhabitants of the area, but also for those who live in areas near the houses that do not meet the standards, since the lack of overhang and irregular dimensions can compromise seismic resistance and structural safety.

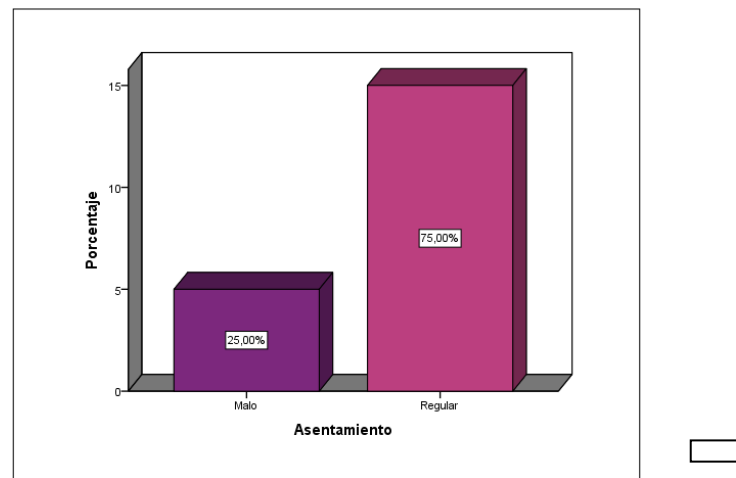
**Figure 3: Settlement in housing**

In Table 3 and Figure 3, the results indicate that most of the dwellings experience moderate settlement, with 75% of them classified as "regular." Although 25% of the homes show a significant settlement and were rated as "bad," it is relevant to highlight the absence of homes with a rating of "good." These findings suggest that, despite the challenges inherent in the settlement in the area, most of the dwellings have maintained a stable structure and reasonable security, considering the forces exerted on the ground and compliance with the regulations of occupation of the territory. In summary, the benchmark-based assessment methodology has provided accurate data to record and understand the structural changes experienced by the majority of the assessed homes.

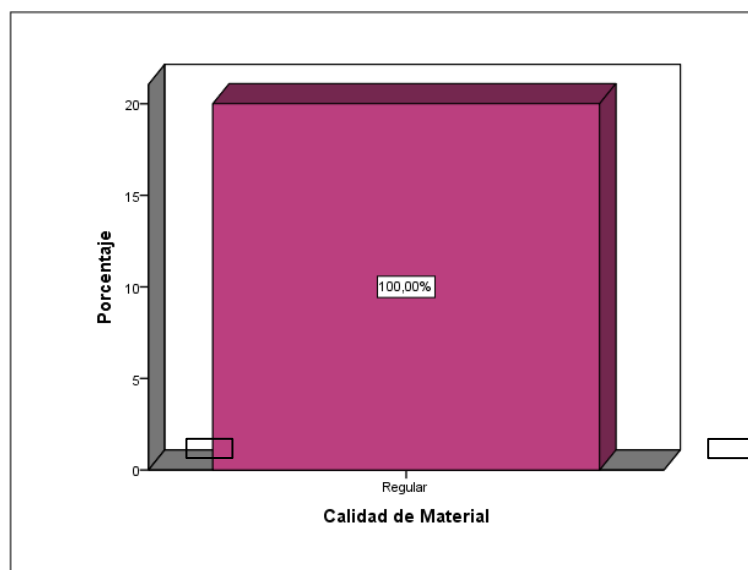
**Figure 4: Material Quality**

In Table 4 and Figure 4, we can observe and analyze that the adobe houses in the Shaullo Chico P.P. have been evaluated in terms of the quality of the material used. The results reflect a univocal trend, as 100% of the homes are in the 'fair' category, while none obtained a 'good' or 'bad' rating. This evaluation was based on a variety of parameters, including detailed visual inspection, tapping tests to assess hardness, water sensitivity to verify moisture resistance, color analysis for uniformity, and confirmation of the absence of contaminants. These results suggest that, although the quality of the material was considered acceptable, it did not reach the best quality standards. However, regarding the quality of the material of the houses, which are made up of adobe walls, sedimentation and other materials, it can be concluded that they provide a safe place to live, complying with the control points and acceptance criteria required by the regulations to guarantee their usefulness and useful life as time goes by.

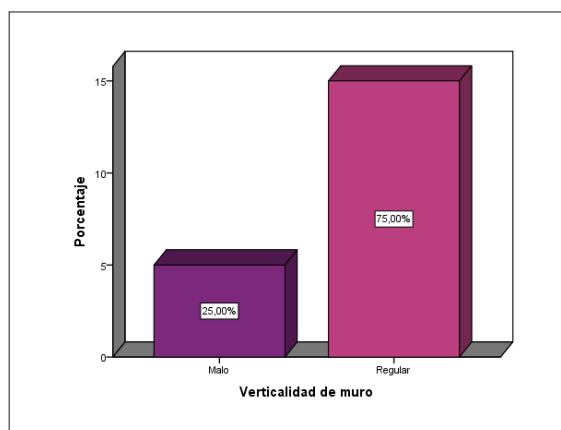
**Figure 5: Verticality of Walls**

Table 5 and Figure 5 show the results of the evaluation of the verticality of the walls in the adobe houses in the Shaullo Chico Primary School. These results indicate that 25% of the houses evaluated presented a "bad" state in terms of the verticality of their walls, which suggests the existence of notable inclinations that represent a potential risk. On the other hand, 75% of the homes were rated as "fair," indicating a slight slope that does not significantly compromise the structure. It is important to note that no homes were found with walls rated as "good." The evaluation of verticality was carried out through detailed visual inspection and measurement tools, such as spirit levels, following specific qualification criteria based on construction and safety standards. These results reflect the presence of certain inclinations and cracks in the walls of adobe houses, possibly due to the lack of support in the foundation and the aging of the material since its construction, which underlines the importance of carrying out structural evaluations and corrective measures when necessary to guarantee the safety and stability of the buildings.

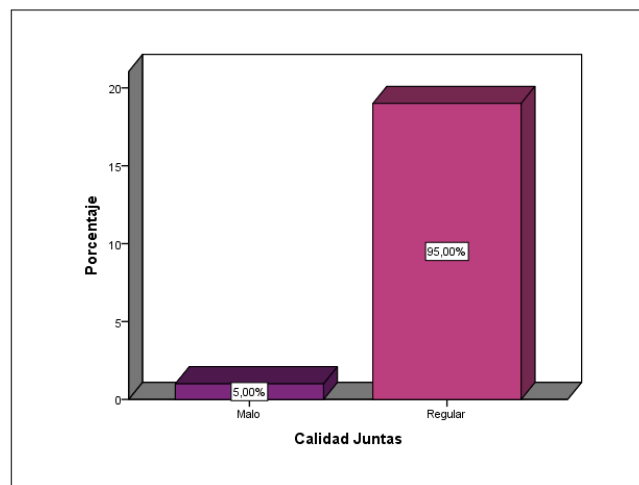
**Figure 6: Quality of Joints in Housing**

In the evaluation of the quality of the joints in the adobe houses in the Shaullo Chico Shopping Center, a rigorous process of visual inspection and detailed analysis of the characteristics of the joints was carried out. The results, as reflected in Table 6 and Figure 6, reveal a significant distribution in the quality of the joints. In this evaluation, 95% of the homes were classified as "fair" in terms of the quality of the joints, indicating the presence of some irregularities such as holes generated by the force that maintain stability and prevent the formation of cracks, crevices or significant spaces. However, 5% of homes received a "poor" rating in this category, pointing to weak joints that could put the stability of the structure at risk. Surprisingly, no homes were found with joints rated as "good," suggesting the need to implement better construction and maintenance practices to achieve solid, well-built joints. This evaluation was based on thorough visual inspection, joint consistency, pressure testing, and a detailed photographic record. These results emphasize the importance of addressing the joints between

adobes to control deformations and maintain the safety and durability of adobe houses over time.

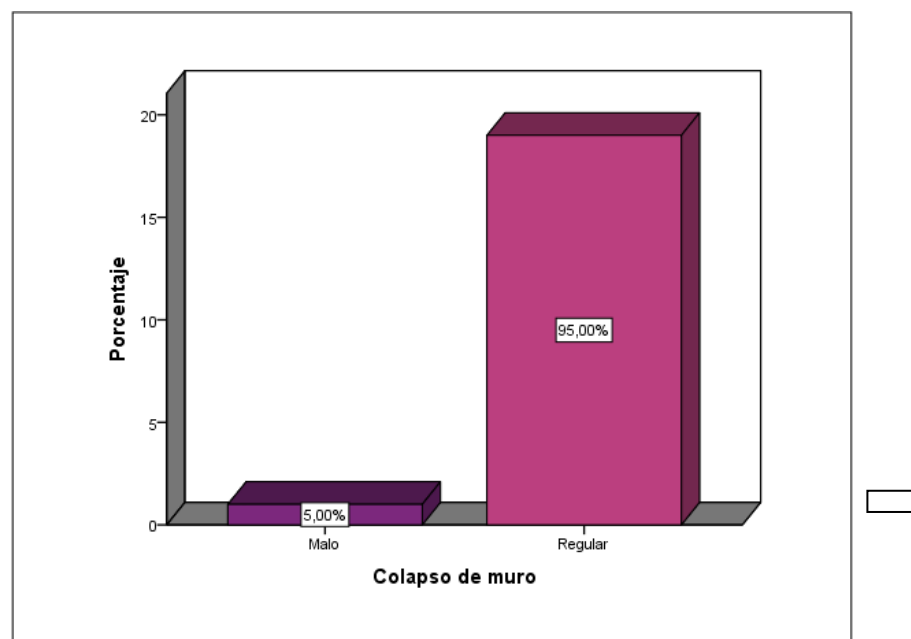
**Figure 7: Wall Collapse**

In Table 7 and Figure 7, it can be seen that the evaluation of the presence of collapse in the walls of the adobe houses in the Shaullo Chico P.P. revealed that 95% of the houses were classified as "regular," which indicates that there have been partial collapses in some walls without endangering the general integrity of the houses. In contrast, 5% of the homes were rated "poor," suggesting the occurrence of complete collapses in one or more walls, posing a significant risk to structural safety. No homes with a "good" rating were identified in this category. This assessment was based on a thorough visual observation of the presence or

absence of collapse, together with an analysis of structural stability. These results indicate that most of the houses in the C.P. Shaullo Chico have maintained their structural integrity in terms of wall collapse, which is essential for the safety of the inhabitants and highlights the importance of implementing preventive measures to avoid future collapses.

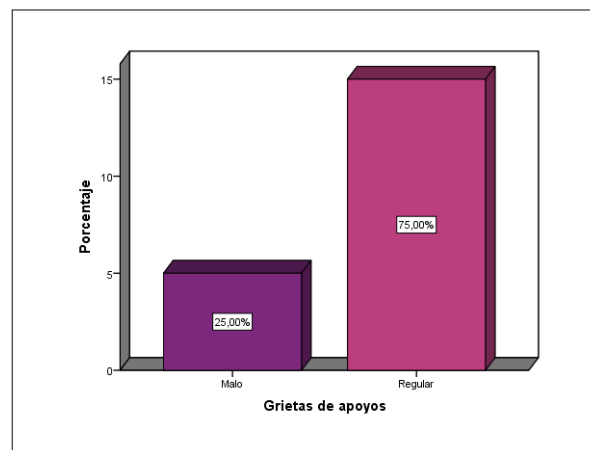
**Figure 8: Cracks in Supports**

In Table 8 and Figure 8, we can observe and analyze that the adobe houses in the Shaullo Chico P.P. present a worrying evaluation in terms of the presence of cracks in the support points. The results reveal that 25% of homes are rated as "poor" when it comes to cracks, indicating the presence of significant cracks that pose a potential risk to housing stability. On the other hand, 75% of the homes are rated as "fair," pointing to the existence of small cracks that, while not significantly compromising the structure at this time, could worsen over time if not properly addressed. No homes with a rating of "good" were found in this category. These findings highlight the importance of taking immediate action to address cracks in adobe housing support points and ensure the safety and durability of structures over time. The evaluation of the cracks was based on a rigorous visual inspection process and established criteria that distinguished

between small and significant cracks, considering various causes such as expansion, dampness, quality of materials and project execution, among other factors that can affect the structural integrity of the homes.

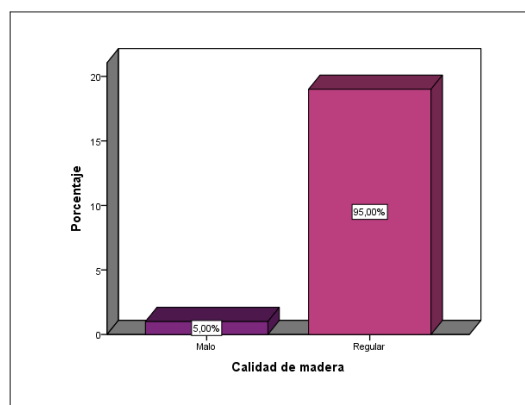
**Figure 9: Quality of Wood in the House**

In Table 9 and Figure 9, 95% of the dwellings were rated as "fair" in terms of the quality of the wood used, suggesting that the quality of the wood is acceptable but not optimal. However, 5% of the homes received a rating of "poor" in this category, noting the presence of low-quality or deteriorated wood in the beams, posing a significant risk to the safety and stability of the homes. Surprisingly, no homes with a "good" rating were found in this category. These results highlight the urgent need to address and improve the quality of the wood used in the beams of adobe houses in the area, since the current conditions expose the structures to humidity and deflections, which could be due to both the age and the quality of the material. This assessment was based on a detailed visual inspection of the timber components in the dwellings.

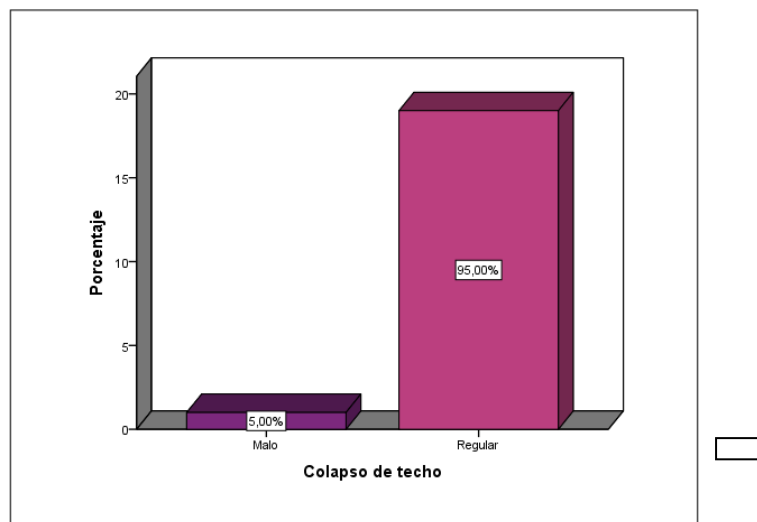
**Figure 10: Collapse in the Roof**

In Table 10 and Figure 10, the results indicate a generally positive situation. Most of the homes earned a rating of "fair" regarding the condition of the roofs, indicating the presence of some signs of displacement or minor damage to the roofs, although there were no cases of partial or complete collapse on any roof, accounting for 95% of the homes evaluated. These results are encouraging as they suggest that adobe dwellings in the area have largely withstood the challenges of weather and climatic conditions, with a minor damage that does not compromise their stability. However, the remaining 5% of the homes had collapses in their roofs, which can be attributed to factors such as abandonment, weather disasters, lack of maintenance actions due to economic limitations and the absence of previous studies to guarantee structural safety. These cases of roof collapse underscore the importance of prevention and proper maintenance

of adobe housing in the area, as well as the need to consider restoration and structural reinforcement measures to ensure the safety of the inhabitants.
