## IMPACT EVALUATION OF SEDIMENT DEPOSITION ON ARABLE LANDS OF YOLA AND ENVIRONS OF ADAMAWA STATE, NIGERIA

**ABSTRACT:** *Sediment depositions on farmlands are among the contemporary hydrogeo-physical process affecting arable lands in most flood prone areas of the world which is receiving ardent attention of research. Arable lands in Yola are seriously receiving continuous sediment depositions which have affected the farming activities. Thus, the study saddled to evaluate the impact sediment deposition on arable lands of Yola and environs. The research consists of three phases. Used of structured questionnaires administered to the farmers, second phase involved direct on-field measurement of depth and width of sediment deposition and the third phase consist of textural class determination of soil samples in the laboratory. The results obtained from the five selected areas shown that Yolde pate, Wurochekke and Anguwan Tabo farm locations loamy clay sediments were deposited to an average depth ranges from 25cm-75cm over period of 10-19 years covering about 15-60 hectares of land where irrigation farming are intensively carried out which has positive impact on their farming activitie

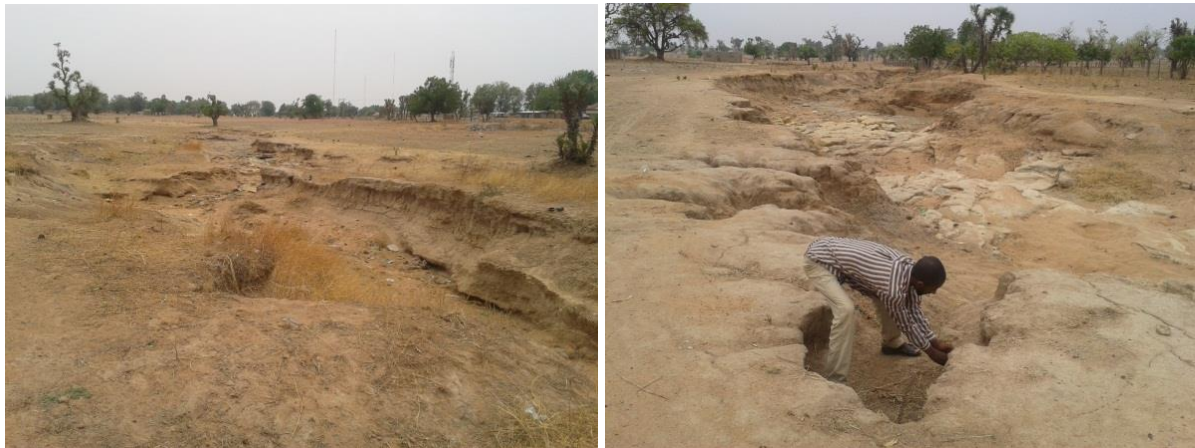
**Plates 1: Devastating Effect of Soil Erosion on Agricultural Lands in the Study Area (Adopted from Sadiq et al., 2019d).**

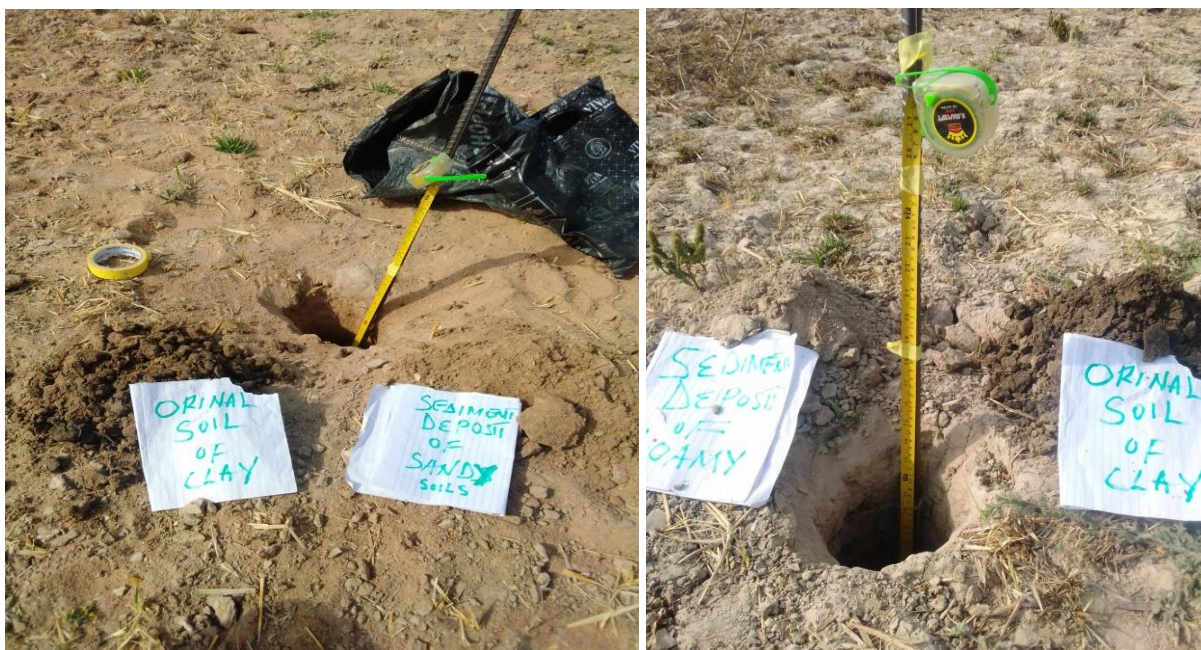
**Plates 2. Original Buried Soils (Paleosols) and Deposited Sediments on Some Farm Location in the Study Area.**

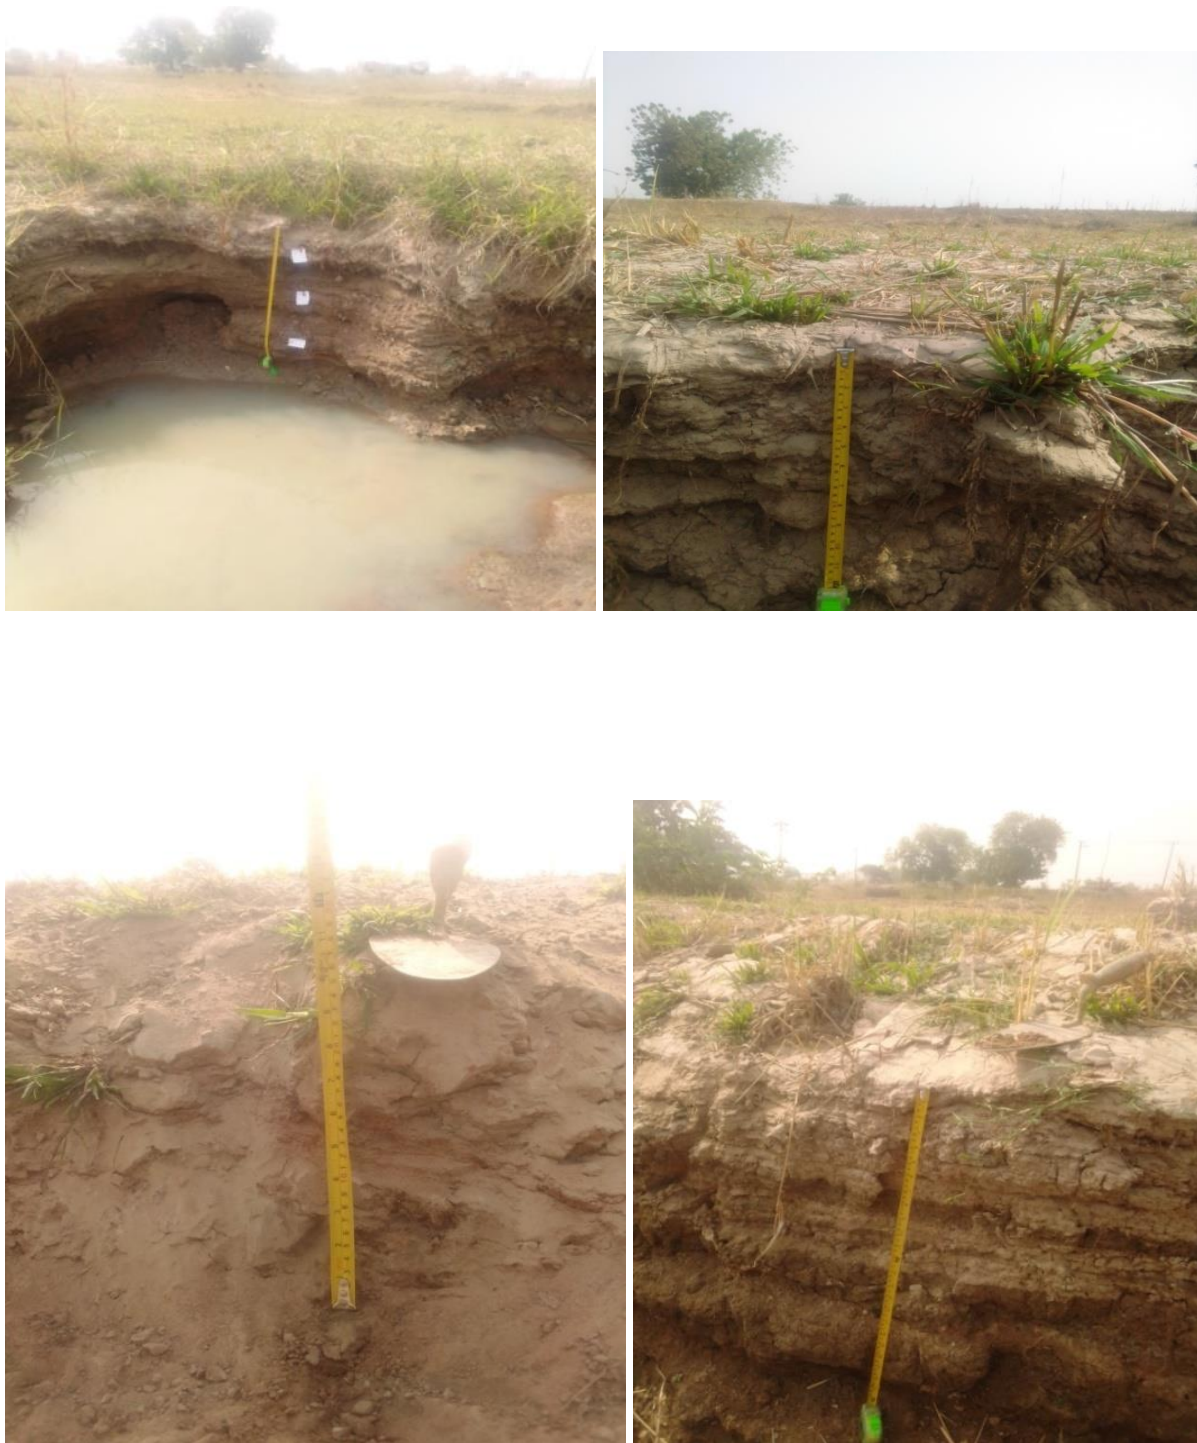
**Plates 3: Stratification of Sediment Deposits at Anguwan Tabo farm Location in the Study Area.**

*Sediment Deposits often show Distinct Stratification or Layering*

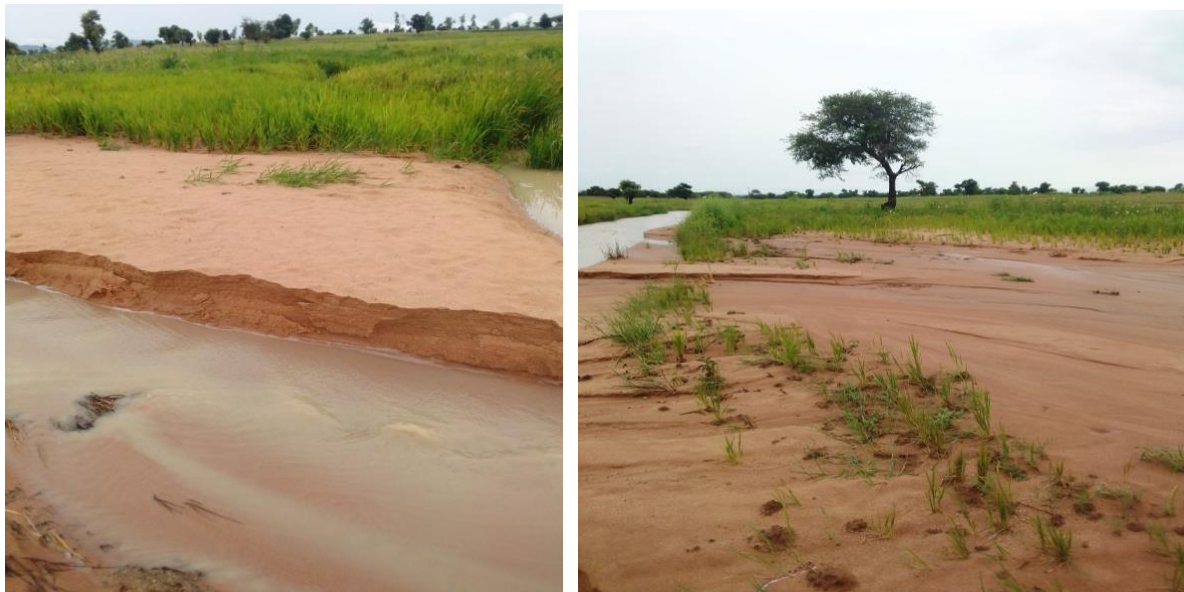
**Negative Impact:** occurs when coarser material is deposited on fine-textured soils there is a more delicate balance, but coarser material generally results in degraded soil structure and physical characteristics and decreased soil fertility. Deposits of infertile sand on a highly productive silt loam that is high in organic matter and nutrients can significantly decrease the quality of the silt loam as depicted in plates 4 below at Mbamba farm location of the study area.

**Plates 4: Deposition of Infertile Coarse Sandy Soils Over Fertile Clay Loam Soil Which Significantly Decreased the Soil Fertility of the Farmlands at Mbamba Farm Location in the Study Area.**

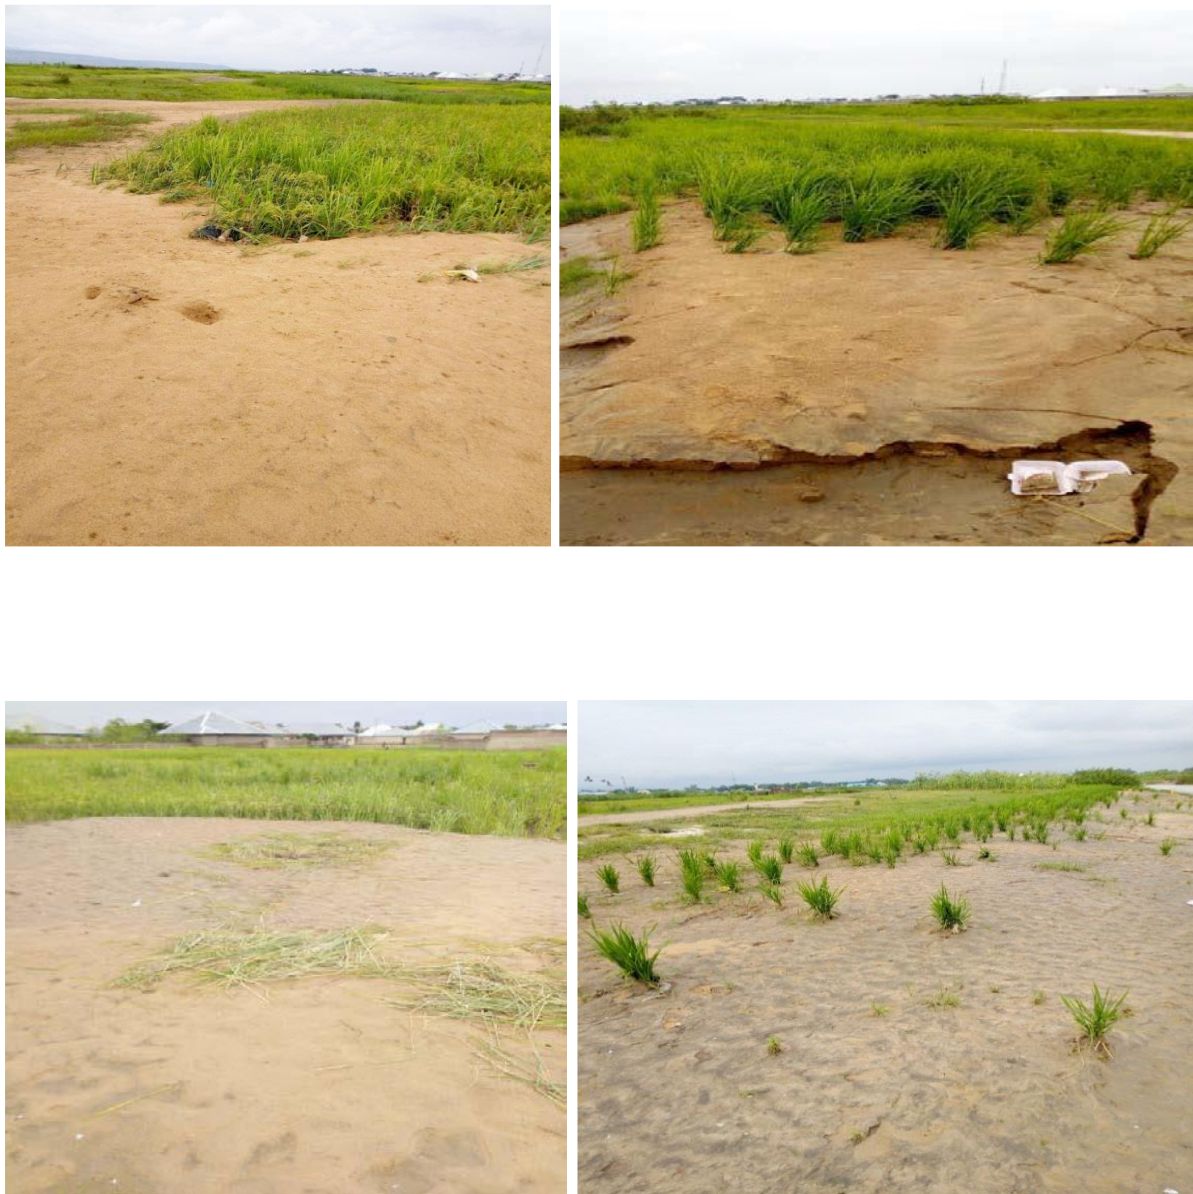
It was reported by Sadiq et al., (2019a) that averages of 41-80 hectares of land were destroyed by the flood in the study area of which sediment depositions are quite among. This damaged was associated with deposition effects on the farm as depicted in the plates 5 below. However, sediment deposit may be of significant important most especially the alluvial and fluvial deposits with high amount of humus content particularly in areas around the river basin having seasonal flooding with gradual sedimentation of fluvial soils. Apparent example occurred on some farm locations near river Benue in the study area as shown in the plates 6.

**Plates 5: Shows the Apparent Effects of Sedimentation Caused by River Flooding at Anguwan Tabo in the Study Area. (Adopted from Sadiq et al., 2019a)**

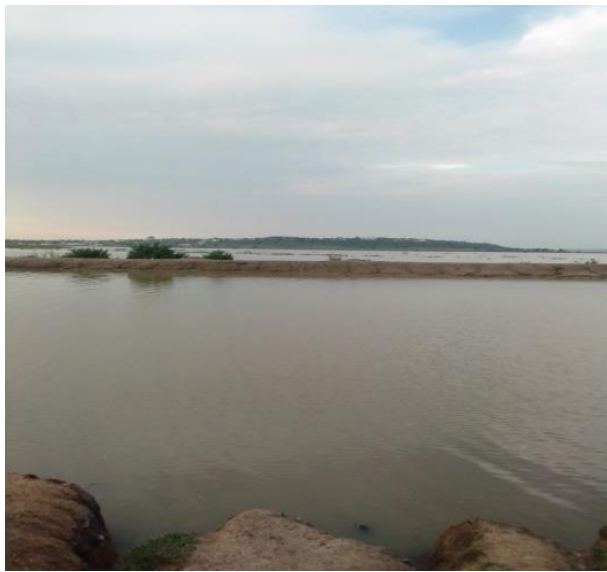
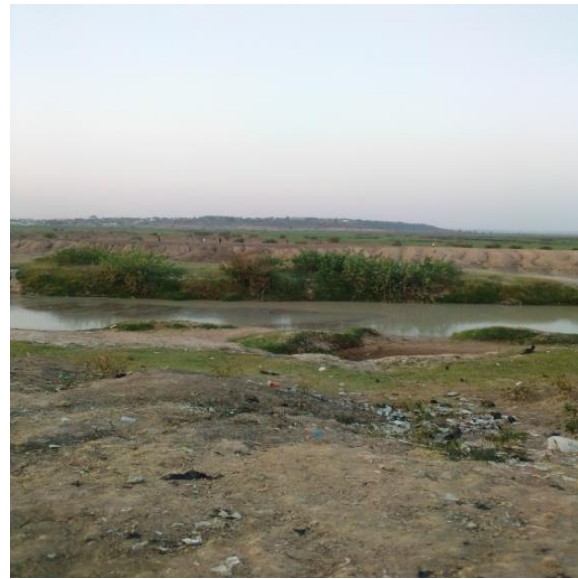
**Plates 6: (A) Seasonal Flooding on Farm Lands in August 2019 and (B) Farmlands after Flooding in December 2019**

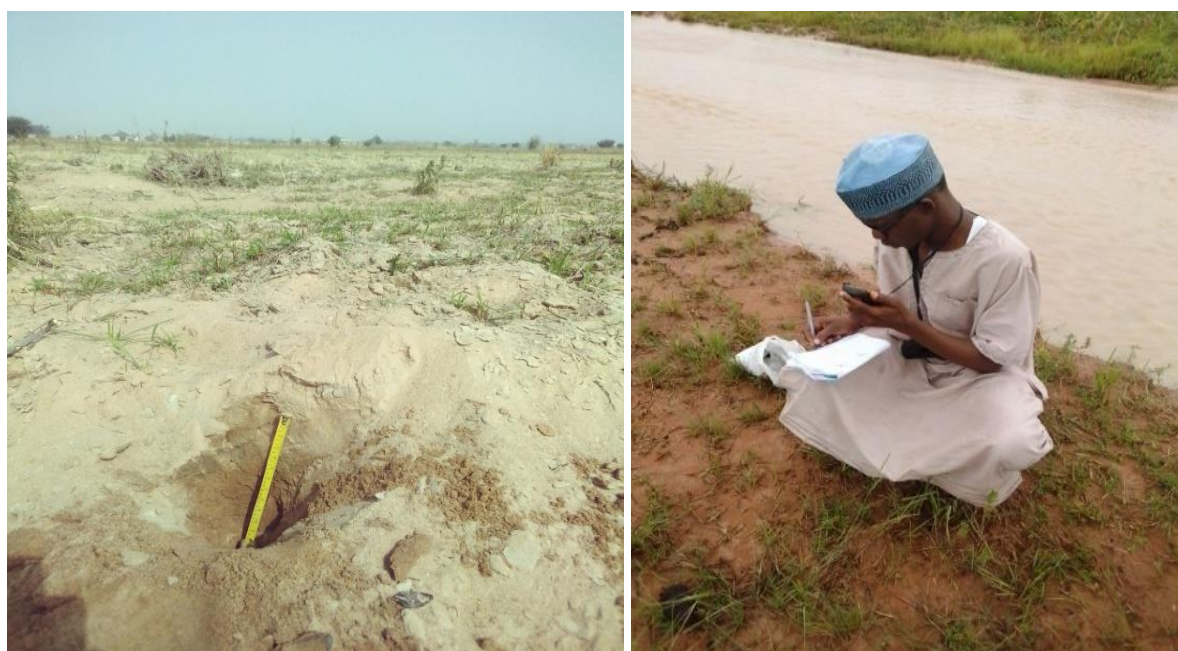
**Plates. 7: On-field Measurement of Sediment Deposit in the Study Area**

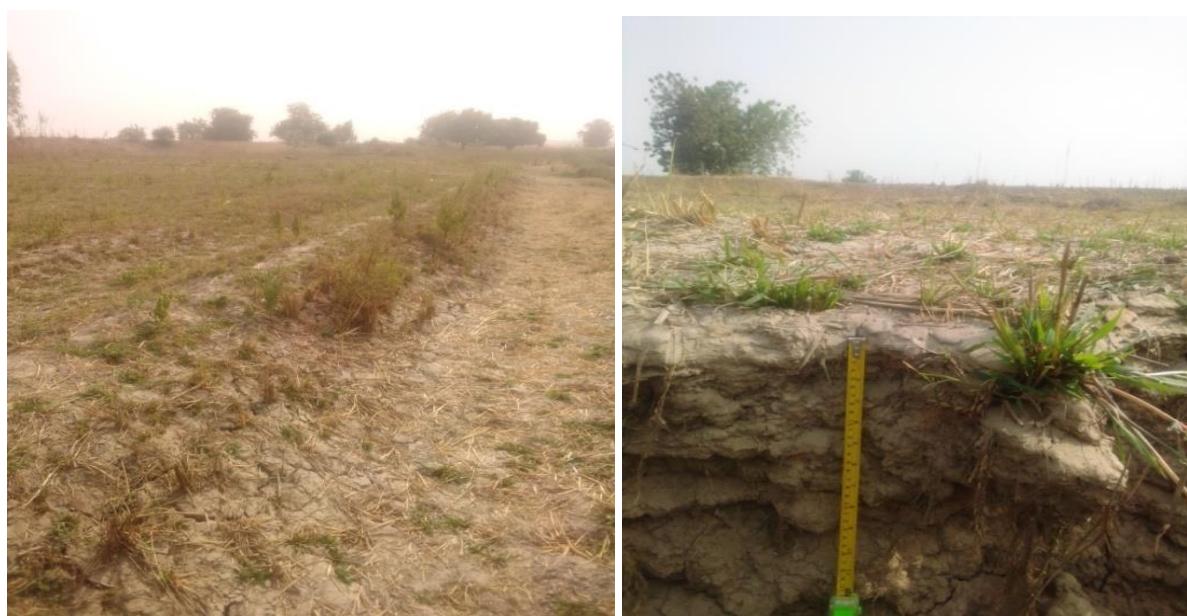
The area occupies a gentle to moderate slope rejuvenating rill to gully erosion having considerable effects on the arable farmlands dominated with maize and rice as major crops grown over 10- 25 years of farming respectively (Table 2). Few trees, grasses and shrubs made the vegetation of the area (Sadiq and Shuwa, 2019). From table 3 above, the original soil type on the farm location was clayey soils which eventually deposited with loamy soil sediments with about 75 cm average depth over a period of 12 years covering about 15-21 hectares of farmlands (see plates 8). Due to the gradual deposition of loamy clay soils with substantive quantity of soil humus ignited the farmers in the area to take advantage of the deposition engaging in irrigation farming practices during dry season and rice farming on some areas in rainy season respectively. There is no damage assessed during this study on the farm location and the impact of sedimentation deposit was positive on the arable land.

**Plates 8: Loamy Soil Sediments at Yolde Pate Farm Location**

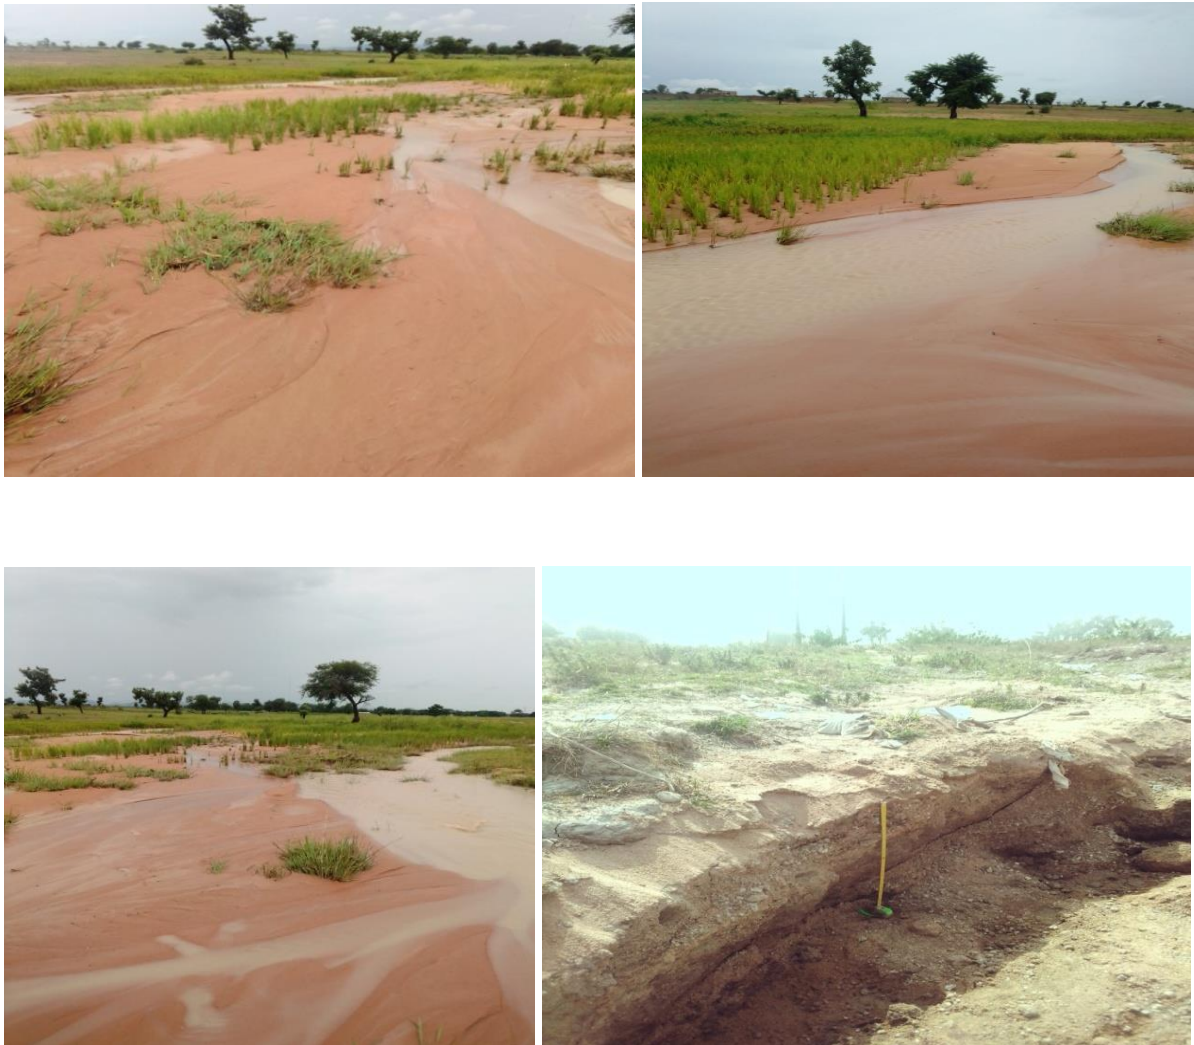
The area is located at the eastern part of Yola south LGA characterized by few tall trees and grasses (Table 2). The farmers engaged dominantly in arable farming where rice and maize been the major crop grown for about 5-35 years conservation experience (Sadiq and Shuwa, 2019). Result from table 3 shows that Mbamba farm location was predominated with loamy soils as original soil which about 5-9 hectares of land in the area were deposited with coarse-fine sandy soils (plates 9) of about 5 years of sediment deposition to about 35 cm soil depth which presently imposed the arable land to an uncultivated land with damaged level of 60 % while an expected recovery period of 20 years with the projected damage remaining after recovery of 30 % estimated from (USDA, NRCS, 1966) respectively. The impact level of the deposition in the deposited areas was assessed to be negative as its impaired arable land uncultivated and unsuitable due to the presence of coarse sandy deposition over loamy soils.

**Plates 9: Coarse Sandy Soils Deposited on Fertile Loamy and Clayey Soils at Mbamba Farm Location in the Study Area**

- i. Potential Management Practices:** Potential management practices include the following;
  - ❖ Use of moldboard plowing, which generally turns 6 to 8 inches of soil over but causes a minimum amount of mixing between the surface and subsurface layers.
  - ❖ Chisel plowing, which causes a greater degree of mixing but generally disturbs the soil to a shallower depth of only 4 to 6 inches.
  - ❖ Deep chiseling, which disturbs the soil to the greatest depth (12 to 24 inches) but generally results in a minimal amount of mixing.
- ii. Preventive Methods:** The best method for addressing sedimentation is prevention, since soil quality generally decreases as the depth of sediment deposition increases. Prevent soil erosion in upstream landscape positions by one of the following methods;

- ❖ Maintaining plant or crop residue cover.
  - ❖ High infiltration rates improvement, and minimal runoff.
- iii. **Conservation Practices:** Conservation practices on upstream watersheds reduce the risk of high-volume flooding and damaging sediment deposition. Dikes, levees, and intercepting channels are used to provide local protection from some flooding and sediment deposition.

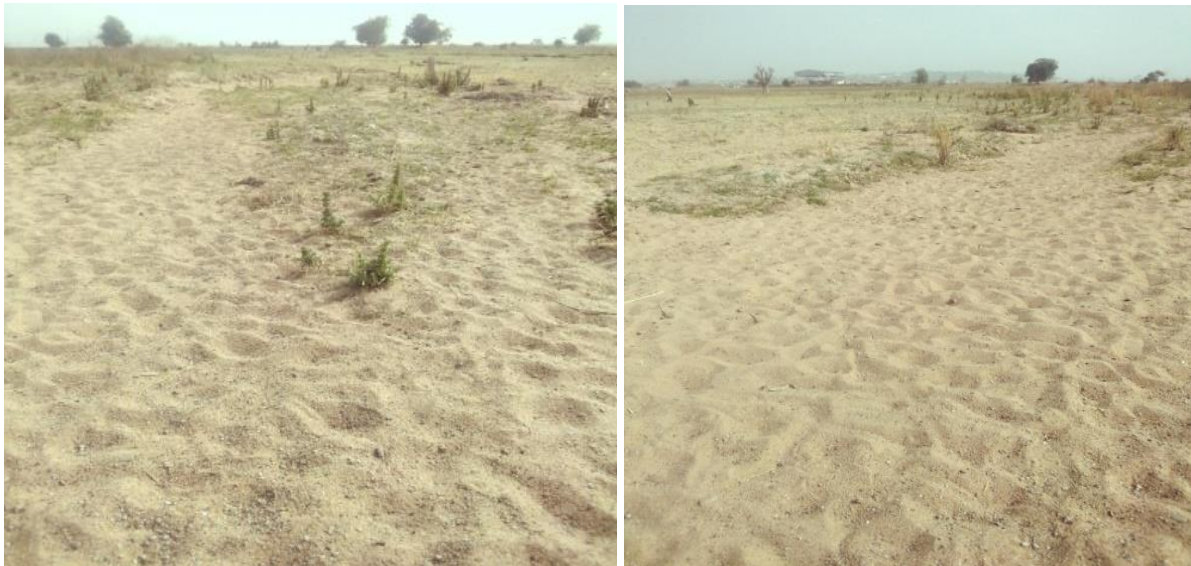
The riverine area is sited on steeply (of about 20-22%) slope gradient with well rejuvenated rill to gully erosion having considerable devastation on farmlands. The vegetation is characterized by tall grasses, tall trees and shrubs dominated with arable farming with about 5-20 years conservation experience mostly maize, groundnut and cowpea along the hilly areas while rice is cultivated at swampy syncline (Table 2), (Sadiq and Shuwa, 2019). Table 3 described the original soils of Bole farm location as loamy which was deposited with coarse sandy texture soils to an average depth of 40 cm covering about 2-7 hectares of arable farmlands over a period of 7 years consequently turned the areas unsuitable for cultivation neither rainy nor dry season as depicted on plates 10 below. Using the USDA, NRCS, rating (1966) the damage level was assessed to 60 (%) with an expected recovery period of 20 years and damage remaining after recovery of 30 (%). Negative impact on agricultural cultivation was assessed for the farm location accordingly.

**Plates 10: Coarse Sandy Soils Deposited on Arable Lands in the Study Area**

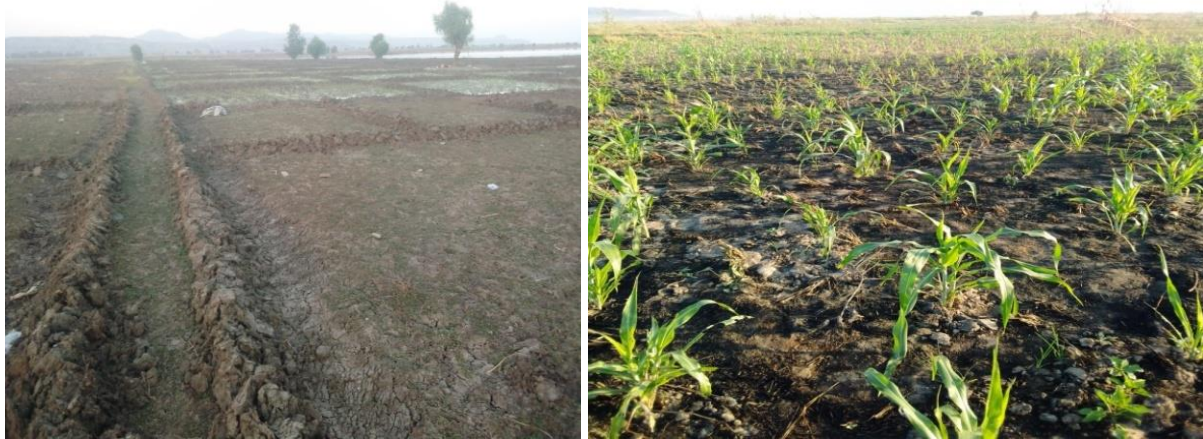
The flood plain area is situated along river Benue basin at North-western part of the study area dominated with tall grasses and few trees, practicing arable farming, irrigation and orchards farming. The area has noticeable rill to gully erosion with notable steep topography having sediments and depositional materials spread over the low-lying adjacent areas. Rice and cocoyam were the major crops grown in the area for over 5-15 years conservation farming experience (Table 2) (sadiq and shuwa,2019). The result on table 3 shown that clayey soils are the original predominated before it fluvially deposited with silt clay loam to an average depth of 55 cm over a period of 19 years covering about 22-60 hectares of arable lands. The perennial flooding of river Benue is mainly responsible for the deposition of fluvial fine textured forming an extensive organically rich soil forming floodplains (fluvisols)

which farmers intensively engaged in irrigation farming most especially the cultivation of local specie of Guinea corn known as “*MUSKUWA*” and it has no any damaged effects assessed for the period of this study as adopted from USDA, NRCS, (1966) accordingly.

**Plates 11: Fertile Fluvial Deposits at Wuro-chekke Farm Location where Irrigation Activities are Intensively Carried Out**

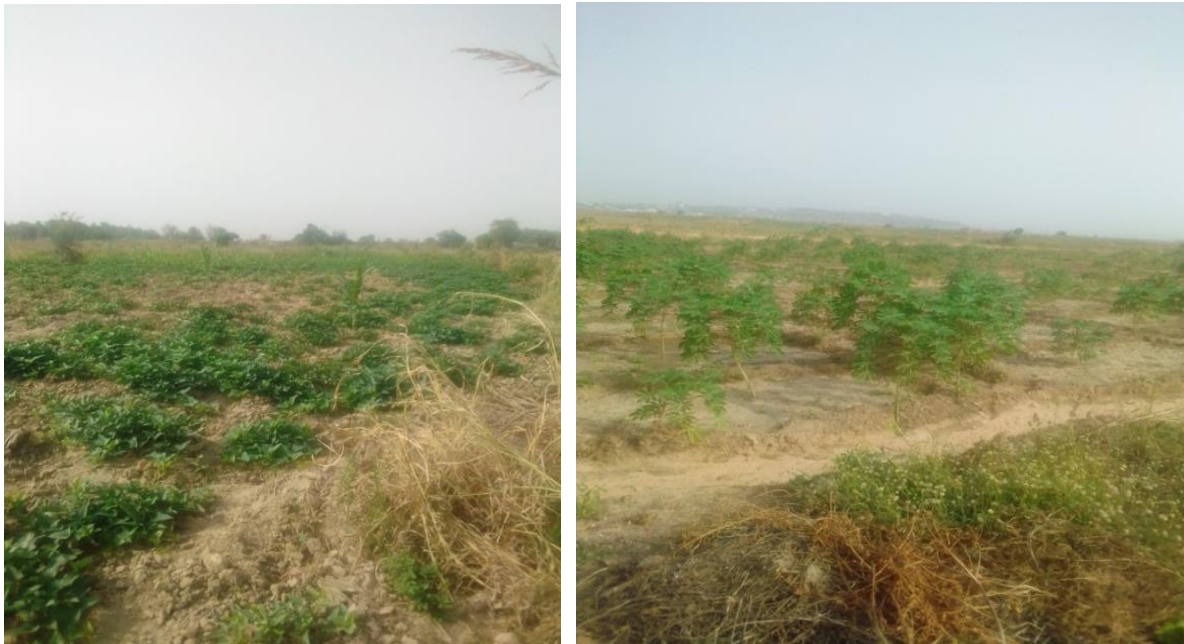
Anguwan Tabo farm location is having similar features with that of Wuro-chekke farm location. The area is situated along river Chochi flood plain from the western area of Yola where farmers practicing arable farming of rice and maize respectively (Sadiq and Shuwa, 2019). Table 3 depicted the original soil type of Anguwan Tabo clayey which was deposited by silt loam alluvial soils covering about 15-30 hectares of arable lands to a depth of 25 cm over an estimated period of 10 years respectively. Due to the fluvial deposit from river Chochi in the area farmers engaged intensively in dry season farming cultivating different types of crops such as practices cassava, groundnut, sweet potatoes and sorghum (see plates 12 below) which have a positive impact on farmers socio-economic status with no damage and recovery period using USDA, NRCS, (1966) accordingly. The alluvial soil is suitable for irrigation farming due to high organic matter content in the alluvial materials deposited after the recession of seasonal floods and the retentions of the soil moisture content which supplement the moisture requirement of irrigated crops.

**Plates 12: Cultivation of Sweet Potato, Cassava and Groundnuts on Sediment Deposit at Anguwan Tabo Farm Location of the Study Area**
