GEOTECHNICAL AND GEOPHYSICAL INVESTIGATION INTO THE CAUSES OF CRACKS IN BUILDING: CASE STUDY OF SOME BUILDINGS IN SCHOOL OF ENGINEERING KOGI STATE POLYTECHNIC, ITAKPE CAMPUS, KOGI STATE NORTH CENTRAL NIGERIA

Onsachi J.M., H.M. Yakubu and Shaibu M.M.

Department of Mineral and Petroleum Resources Engineering, School of Engineering, P.M.B
1101 Kogi State Polytechnic, Lokoja.

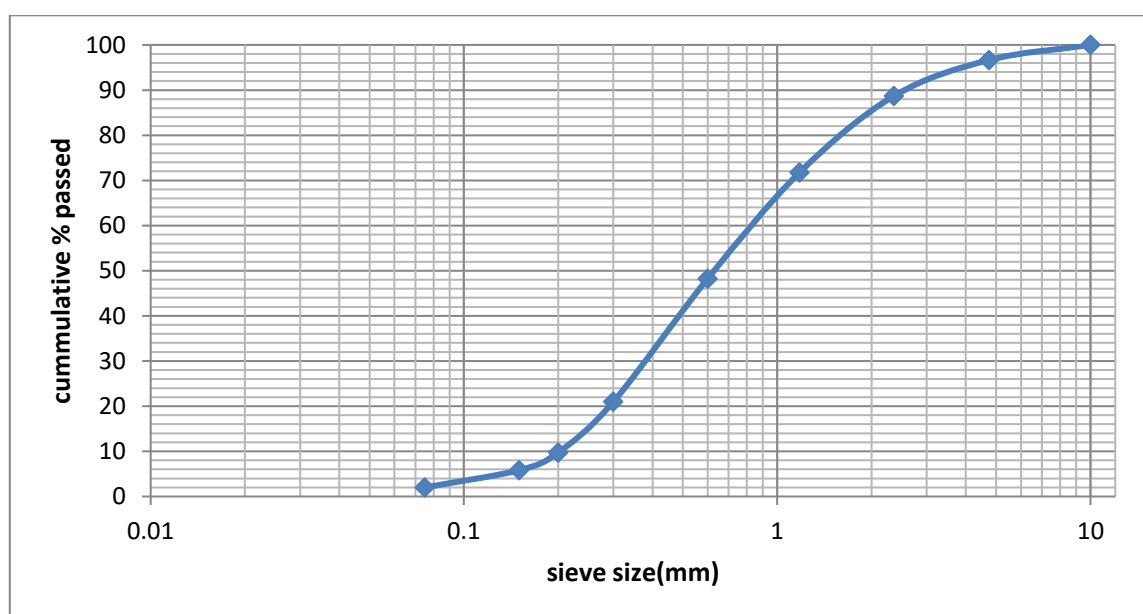
**Figure 8: Graph of Particle Size Distribution L3****Table 5: Sieve Analysis L4**

The distribution of particles in the soil are presented by grading curves on a particle size distribution charts, as shown in fig 4.2- 4.6 more than 50% of samples fall within medium to coarse grained sand from the rounded nature of the grains, it shows that it is well sorted and graded.
