AN EVALUATION OF CAUSES, EXTENT, PATTERN AND EFFECT OF GULLY EROSION ON SOME SELECTED ARABLE LANDS IN YOLA SOUTH LGA, NORTH-EASTERN PART OF NIGERIA

ABSTRACT: *The study attempts to estimate the causes, extent, pattern and effect of gully erosion on some selected arable lands in Yola South LGA, North-eastern part of Nigeria. Two hundred fifty (250) selected sampled farmers were administered well structured questionnaires in each farm location (Mbamba, Bole, Yolde pate and Wuro-chekke) on the causes, effects and control method of gully erosion and the obtained data were analyzed using simple descriptive statistics. Representative soil samples of the gully affected areas were collected and analyzed for soil related erosion properties (structure, texture, OM, porosity and permeability) using standard laboratory procedures. Direct on-field observation, identification and measurement of gully morphological parameters (size, shape, length, depth, width) were obtained and used to calculate extent of the gully (runoff area, gully density and soil loss) respectively. The result revealed that OM content of the area ranges from 1.52-2.10, porosity 38%-43%, clay loam and sandy loam were domina

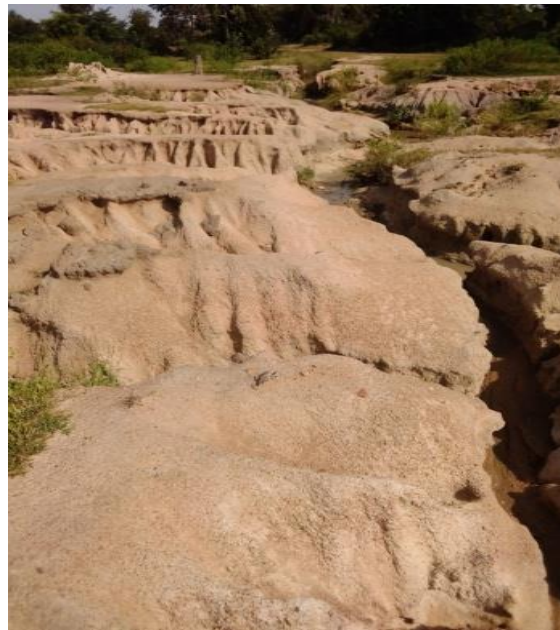
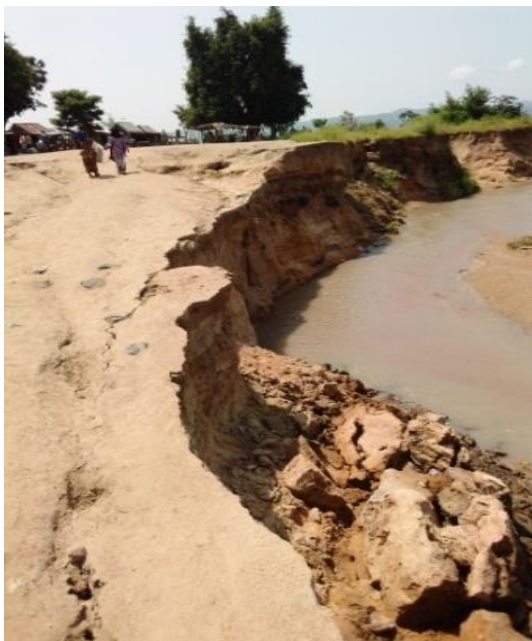
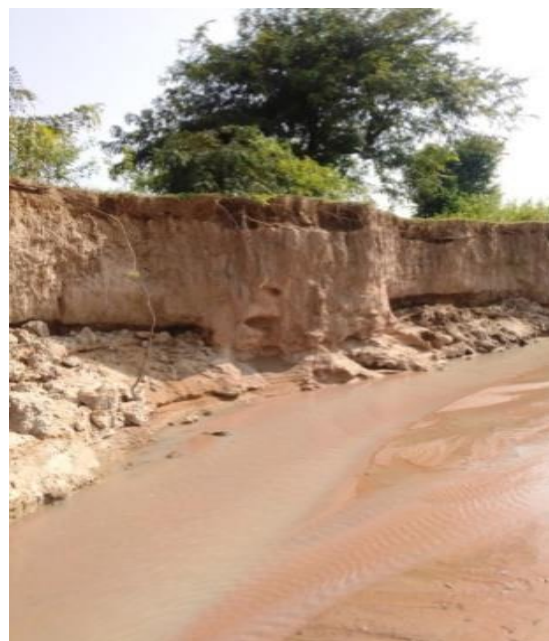
Plates 1: Shows the Evidences of Devastating Effects of Gully Erosions on Farmlands in Yola South LGA, of Adamawa State.

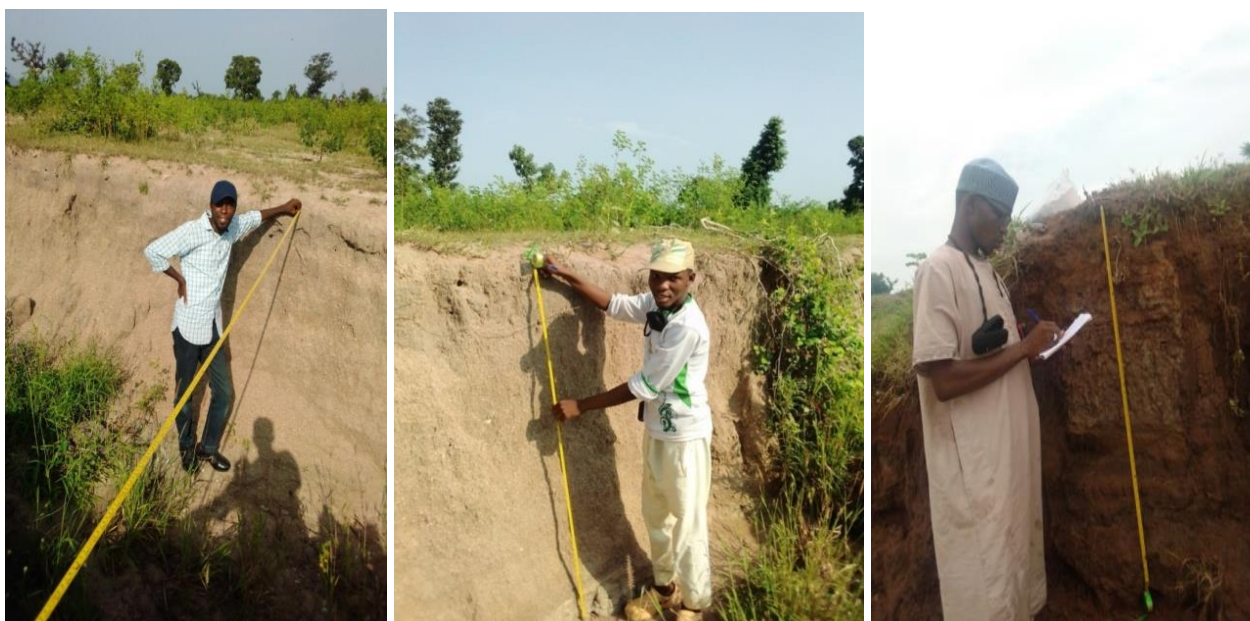
Plates 2: Shows the Physical Observation, Identification and Measurements of Gully Erosions on Different Farm Location in the Area During the On-Field Survey.

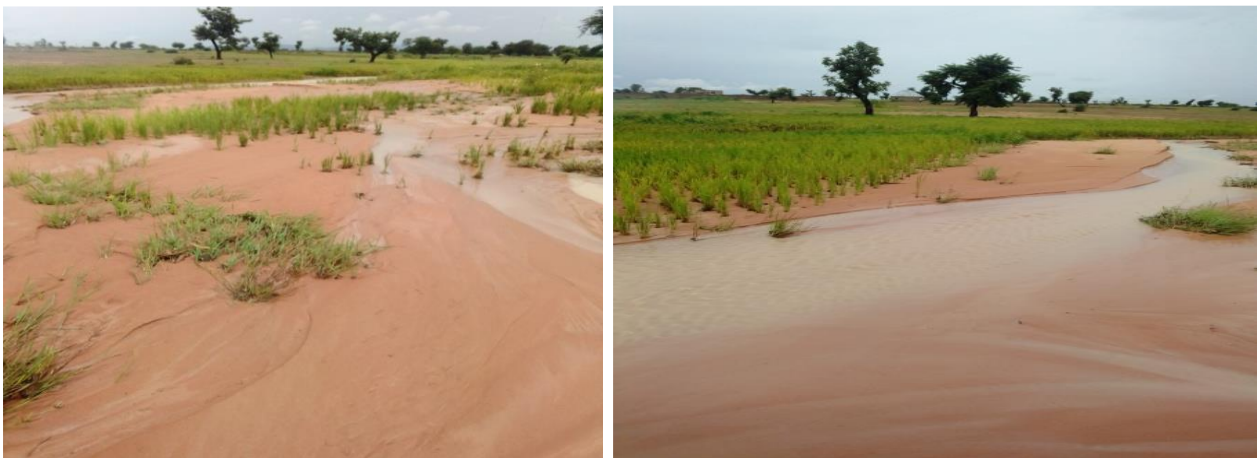
Plates 9: Coarse Sandy Soils Deposited on Fertile Loamy and Clayey Soils at Mbamba farm Location in the Study Area

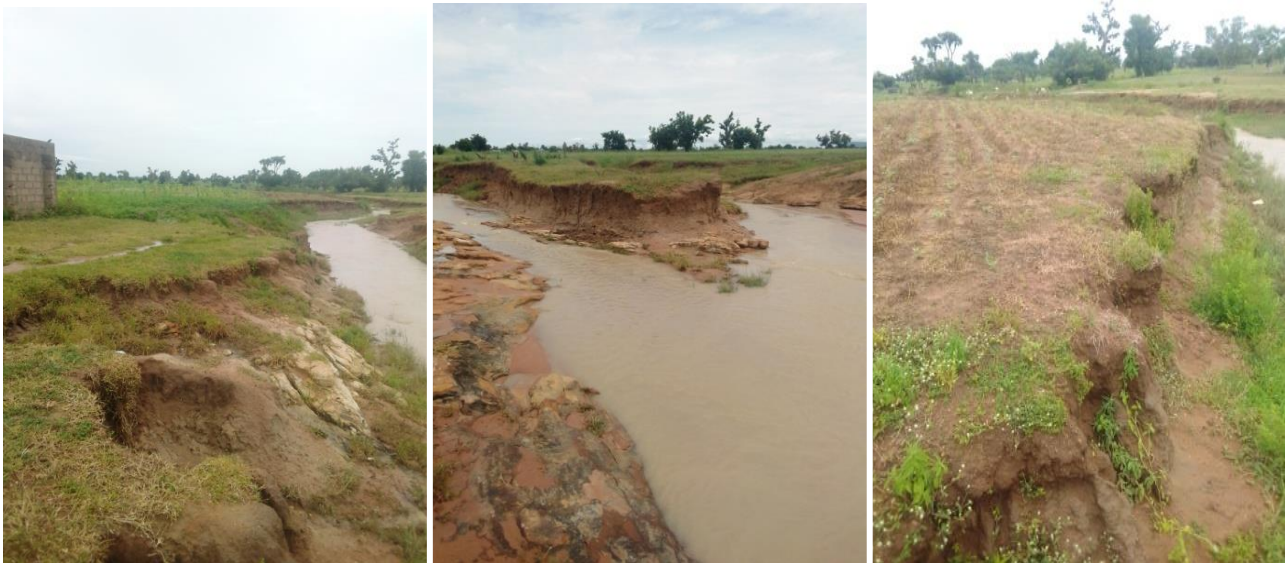
Plate 4: Shows Some Gully Erosions at Mbamba Farm Location in the Study Area

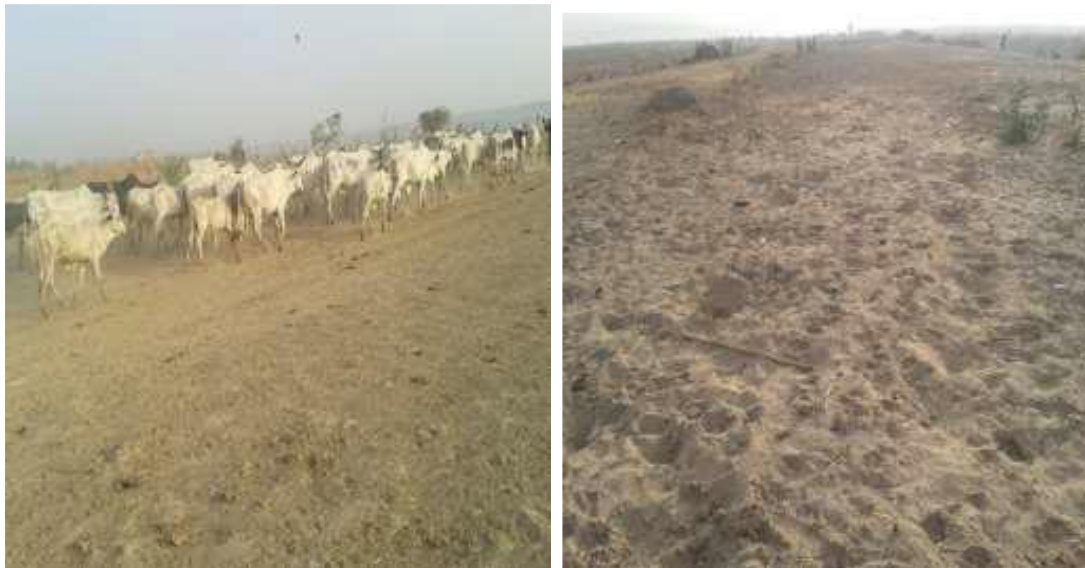
Plates 5: The Grazing Animals Trampling on Farmlands thereby Destroying the Soil Structure

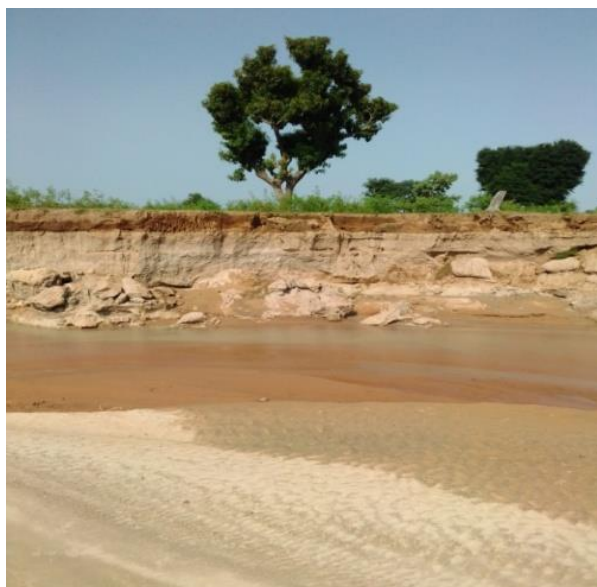
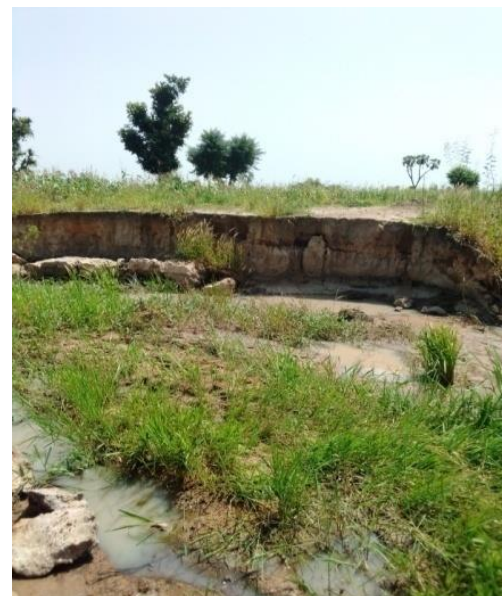
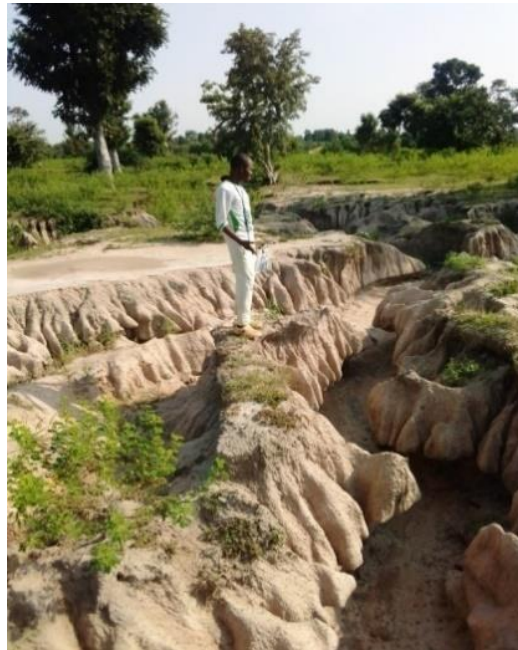
developmental stage actively causing an extreme damage to the farmlands in the area. Likewise, table 5 shows the result on the extent and characteristics of gully erosion on the arable lands, where 6 gully erosions were identified having an average length of 130 m, average width of 4.0 m, average depth of 3.7 m, affected an estimated runoff area of 3, 120 m² with density of 0.0416 m/ m² and 11, 544 M³ of soil was lost annually on the various farmlands in the area. Thus, Murck, *et al.*, (1996) estimated global rate of soil loss through erosion at over 25 billion tons per year for both rural and urban environments. Effects of gully erosion on arable lands were portrayed on table 6. The results revealed that at Bole farm location majority of the farmers (28.8%) agreed that loss of productive land by the gully erosion was the utmost effects coupled with reduction of crop yield which recorded 21.2 % (table 6). Also, sediment deposition on arable lands attributed to 18 % of the farmers and destruction of farm facilities received 13.2 % respectively. This finding concord with the recent findings of Sadiq *et al.*,(2019b) reported that an estimated average decline of 22% of farm productivity, was observed right from the time the land was put under cultivation to date, due to decline in soil fertility on arable farmlands of Yola South LGA. Not only that soil erosion negatively impacts on ecology and can lead to reduced crop productivity worsened water quality, lower effective reservoir of water levels, flooding and habitat destruction (Park *et al.*, 2011)]. For control method employed by the farmers, planting of trees and grasses was conceived by most of the farmers (26 %) in the area. Similar findings were reported by Sadiq and Shuwa (2019) explained that adoption of vegetative barriers as biological techniques was found to be most employed (24 %) by the farmers and agroforestry was adopted by 20 % due to the presence of tall trees in the area for sustainable food production. Hence, agroforestry is an important component of farming systems in humid tropics not only in terms of nutrient recycling and soil conservation but also in supplying food and firewood to the small farmers and ensuring overall sustainability of production (International Institute of Tropical Agriculture IITA.1986). Moreover, 22 % have adopted construction of water ways to redirect the water away from the farmlands and the use of sand bags attracted 18 % of the respondents in controlling the gully erosion as presented on table 7 correspondingly. Evidences of gully erosion were portrayed on plates 6 below.

Plates 6: Evidence of Gully Erosion at Bole Farm Location in Yola South LGA

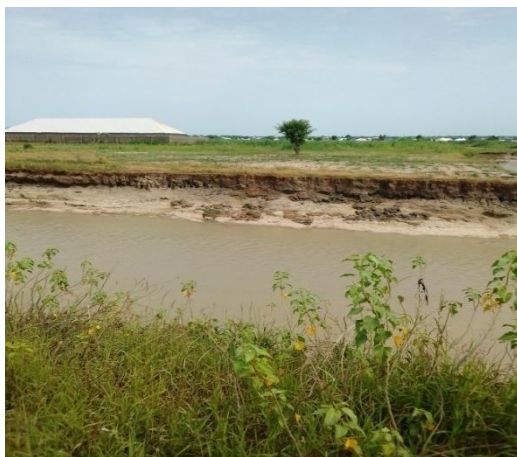
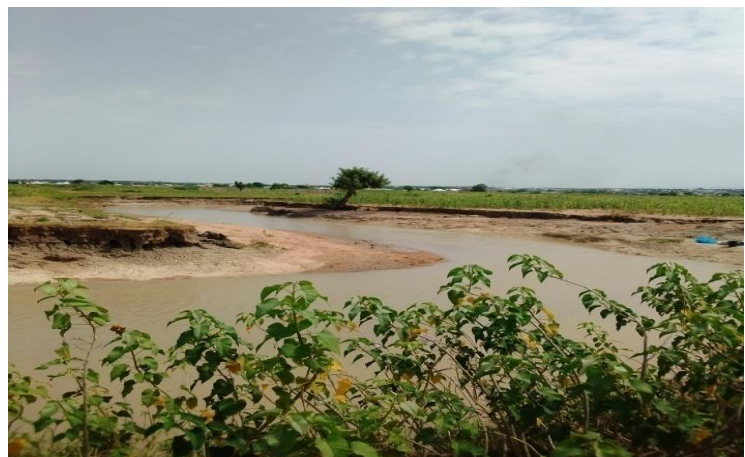
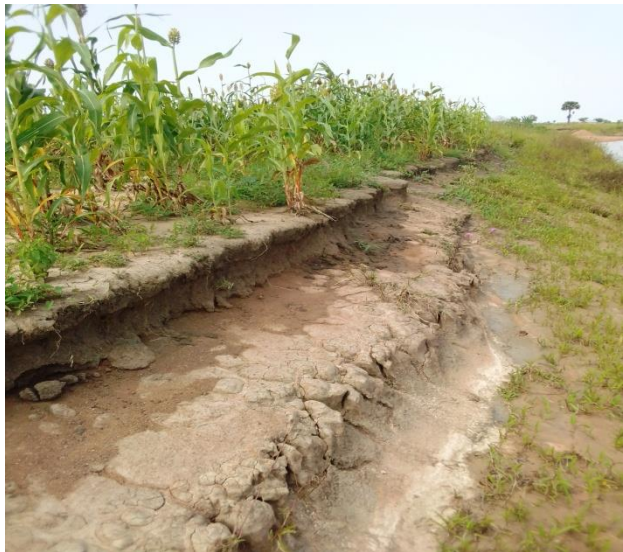
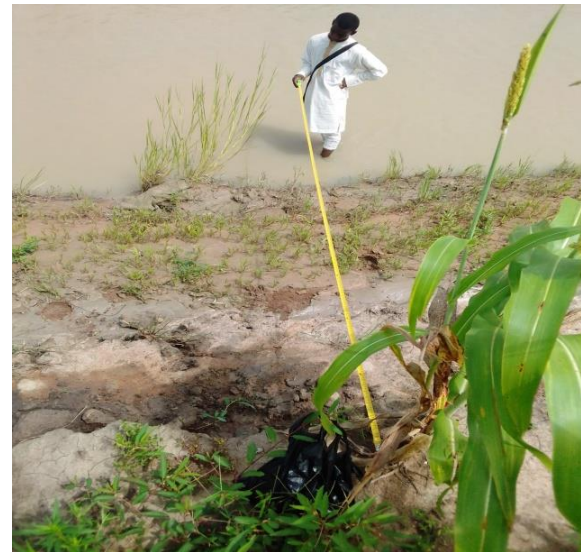
grazed lands have been found to be 100- 1000 times higher than natural background erosion rates. Furthermore, large gully erosion was appeared dominant in the area characterized with U-shape and trapezoidal shape on steep slope having a discontinuous nature under healing stage which caused an extreme damage on farmlands but with less activity potentials as depicted on table 4. Sadiq and Shuwa, (2019) explained that Yolde Pate area occupies a gentle to moderate slope rejuvenating rill to gully erosion having considerable effects on the arable farmlands dominated with maize and rice as major crops grown over 10- 25 years of farming respectively. Table 5 shows the extent and physical characteristics of gullies in the study area. The results revealed that at Yolde pate area 3 gullies were identified having an average length of 150 m, average width of 5.8 m, average depth of 3.3 m with an estimated runoff area of 2, 610 m² having a density of 0.0574 m/ m² with an annual soil lost of 8, 613 M³ respectively. In the farm area, gully erosion was revealed as most variable and common with 27 % of the respondents (Sadiq et al.,2019b) Likewise, a study conducted in 2012 at Bangshika in Adamawa state of Nigeria, showed that volume of soil loss in gullies range from 697 M³ to 3,362 M³ (Babayi *et al.*, 2012). Similarly, loss of productive land was assessed (26%) as the major effects of gully erosion in the farm location as portrayed on table 6, followed by sediment deposition on arable lands 20 %, then 15.6 % attributed the effect to reduction of crop yield and 15.2 % of the farmers agreed to have damaged infrastructures in the area. Sadiq and Faruk, (2020) found that some farm locations at Yolde pate were deposited with loamy soil sediments with about 75 cm average depth over a period of 12 years covering about 15-21 hectares of farmlands, due to the gradual deposition of loamy clay soils with substantive quantity of fluvisols ignited the farmers in the area to take advantage of the deposition engaging in irrigation farming practices during dry season and rice farming on some areas in rainy season respectively. Generally, in Yola South LGA, about 73% of farmlands in the area are affected by erosion at different stages of development (Sadiq *et al.*, 2019b). A series of studies showed that the gully-based valley sediment yield accounted for 10% to 94% of the total watershed sediment yield (Poesen, *et al.*, 2003). At Yolde Pate farm location result from table 7 shows that most of the farmers adopted the use of sand bags (22 %) while 18 % of them employed planting of trees and grasses and contour ploughing, diversion of surface water techniques and water ways construction each was adopted by 14 % of the farmers in the area towards controlling the gully threats on their farmlands effectively. This is because the techniques appeared more physical which required low technical know-how and easy to employ. Plates 7 below depicted some evidence of gully erosion at Yolde pate farm location.

Plates 7: Some Evidences of Gully Erosions at Yolde Pate Farm Location in Yola South LGA.

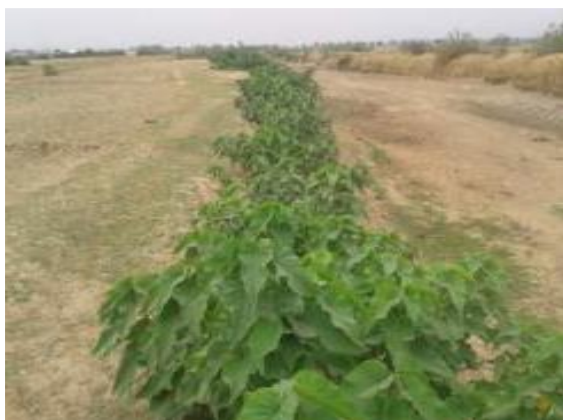
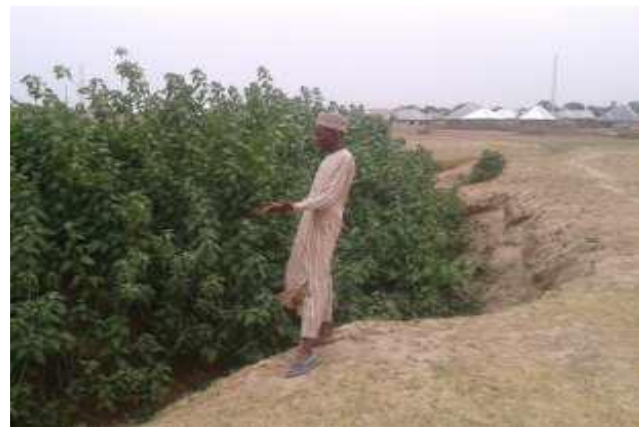
Pates 8. The Use of Vegetative Plants as Barriers to Control Soil Erosion at Wuro-Chekke Farm Location.
