## EVALUATION OF ROAD PAVEMENT FAILURE: A CASE STUDY OF FEDERAL MEDICAL CENTER ROAD, JABI, ABUJA

<sup>1-3</sup>Faculty of Engineering, Department of Civil Engineering, Baze University, Abuja.

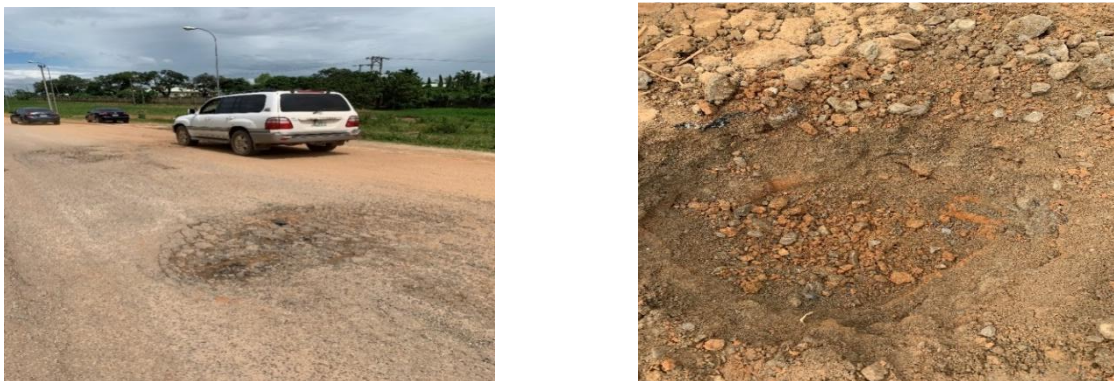
A sufficient number of samples were gathered from the failed portion of the flexible pavement/roadway study area and sealed in an air-tight sack to prevent natural air from tampering with the soil sample. The sample obtained is from three failed sections of the road categorized as Sample A, Sample B and Sample C. The materials were transported to the laboratory of Baze University. These tests were performed according to AASHTO following the BS 1377 method, part 2: 1990. The results will be compared to the Federal Ministry of Works, Housing and Transport of Nigeria's General specifications (Roads and Bridge). Below are some failure types on the road sections with the Samples Obtained.

Figure 2.0: Showing Crack Types Damaged and Their Sample

In conclusion, the test findings demonstrated that the soil materials employed along the Federal Medical Centre Road were exceptional, good, and appropriate to support road building/construction. Factors contributing to road failure include bad drainage conditions, poor workmanship, lack of sloping, and improper shoulder treatment.

- a. To extend the life of the, the nearby drainage system needs to be properly repaired or rebuilt.
- b. Sloping of the road is strongly advised in order to drain off the water from the surface of the pavement.
- c. The damaged road section needs to be correctly repaired using suitable materials.
- d. The shoulder of the road should be treated properly.
- e. Ensuring the maintenance of any kind of defect on the road is carried out at suitable time.

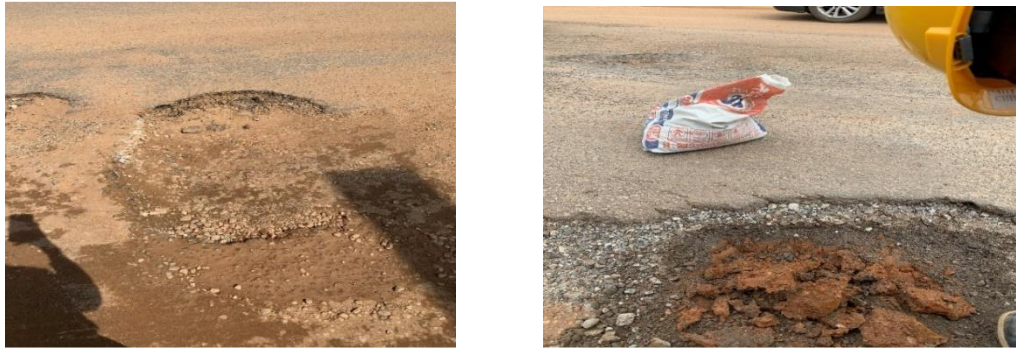
*Figure 2.1: Showing Potholes Type Damaged and Their Sample*

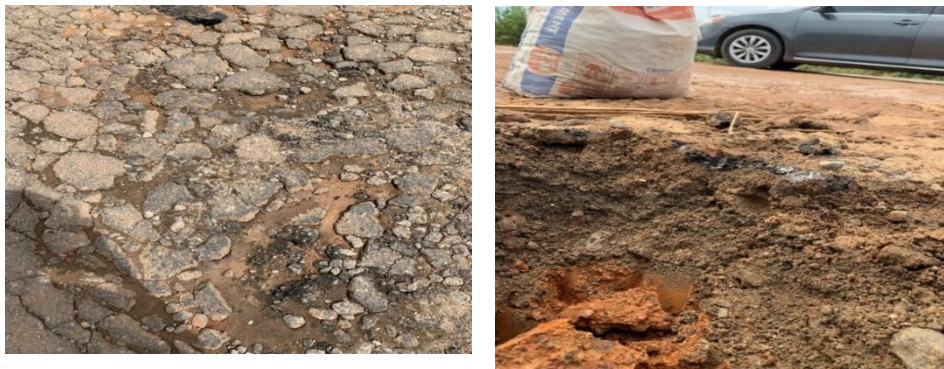
*Figure 2.2: Showing of Distress Damaged and Their Sample*
